Roof & Gable Repairs & Re-Roofing with Swifts

Follow these simple guidelines to comply with the law and keep Swifts safe and breeding in your roof

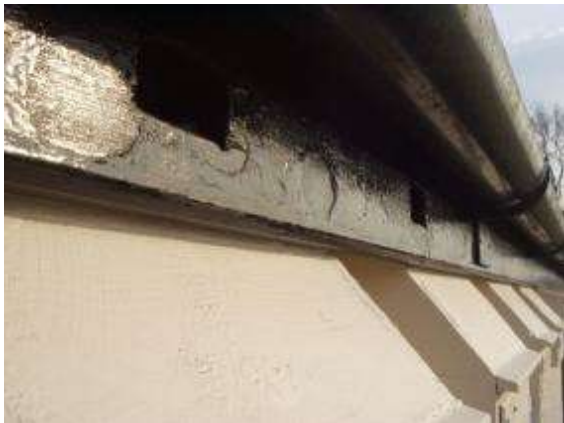
Holes cut in the facing boards let the Swifts reach their nests in the eaves of this chapel
Photo © Mark Glanville

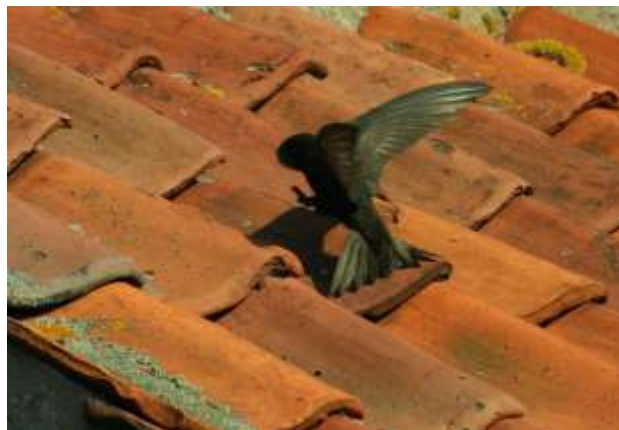
A Swift entering a roof via a displaced pan tile. The nest is on the roofing felt below
Photo © Bill Ball

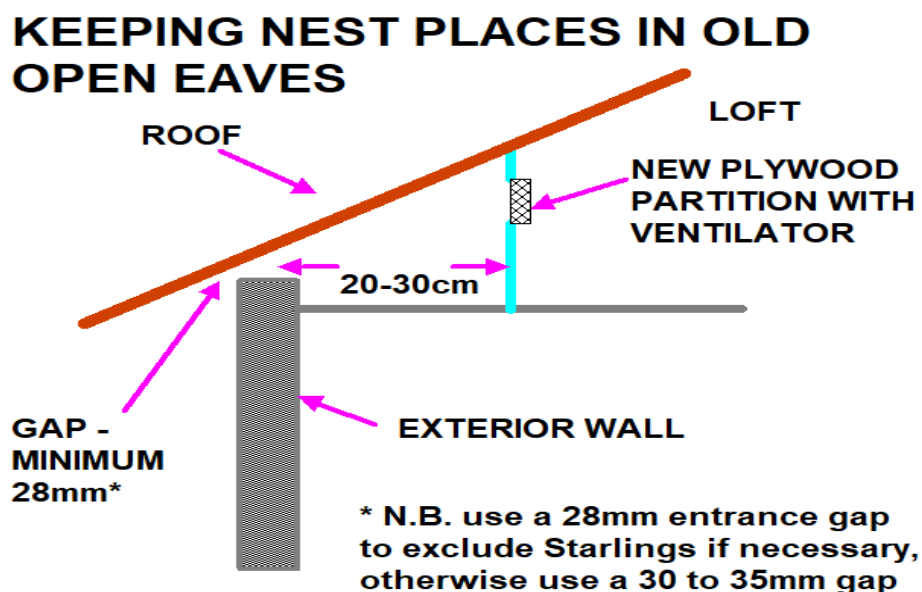
If you have to, install a ventilated plywood partition at least 30cm inside the loft to enclose the Swift nest areas and make the loft area usable, as shown below. *More drawings and details are shown on the last page*

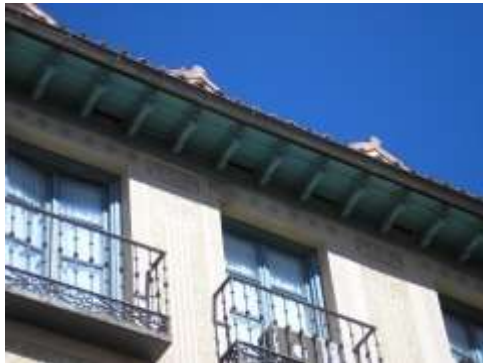
Swifts breed inside the eaves of this hotel at the Escorial, in Spain. Access slots (seen as dark lines at the top of the wall) are left free for them to enter and also to ventilate the roof space.

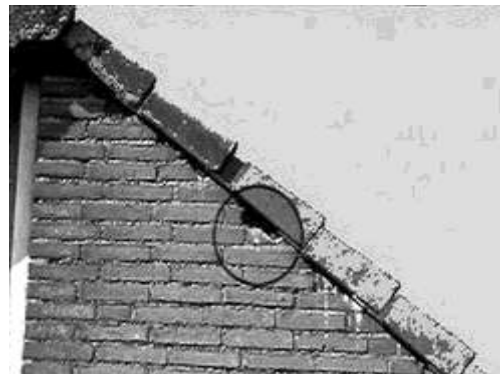
Swifts nest under the tiles on the brick ends of this roof. Repairs would evict them, but leaving the bricks as they are and fitting deeper tiles, offset to maintain the Swifts' access from below, will provide weather proofing and still let the Swifts nest

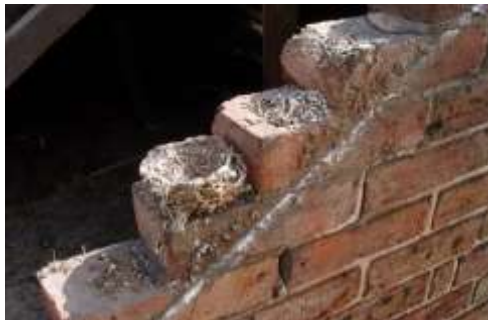
A Swift nest on a gable brick end, exposed when the barge boards were removed. Swifts can nest in very restricted places

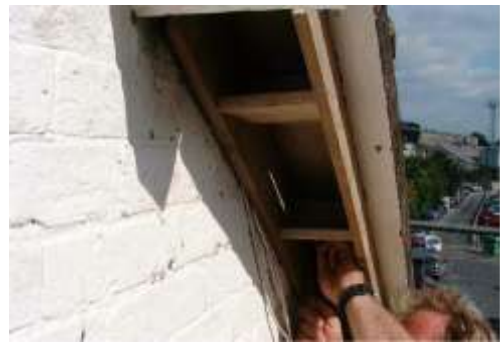
The gable brick ends shown exposed on the left have been fitted with bargeboards containing staircase type nest holes. These will be faced with a plank with entrance holes cut for the Swifts to access the new nest places inside

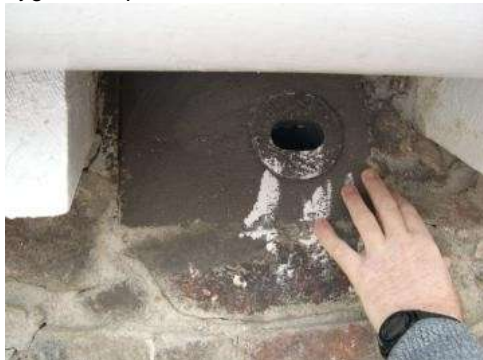
A Schwegler "Swift Brick" inserted into previously open eaves to provide a replacement Swift nesting place. The roof of this NHS hospital had to be sealed to meet hygiene requirements, but the Swifts' nests were saved

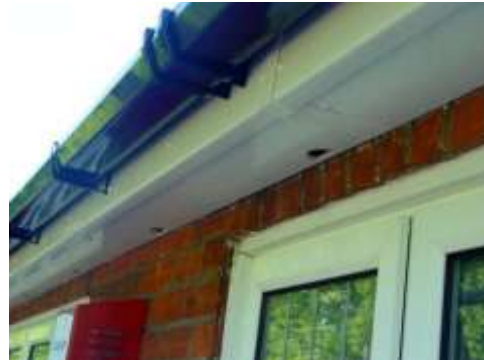
Plastic soffits and gutters have been fitted to this re-roofed house. Holes have been cut in the soffits close to the wall to provide access for the Swifts to their nests in the eaves

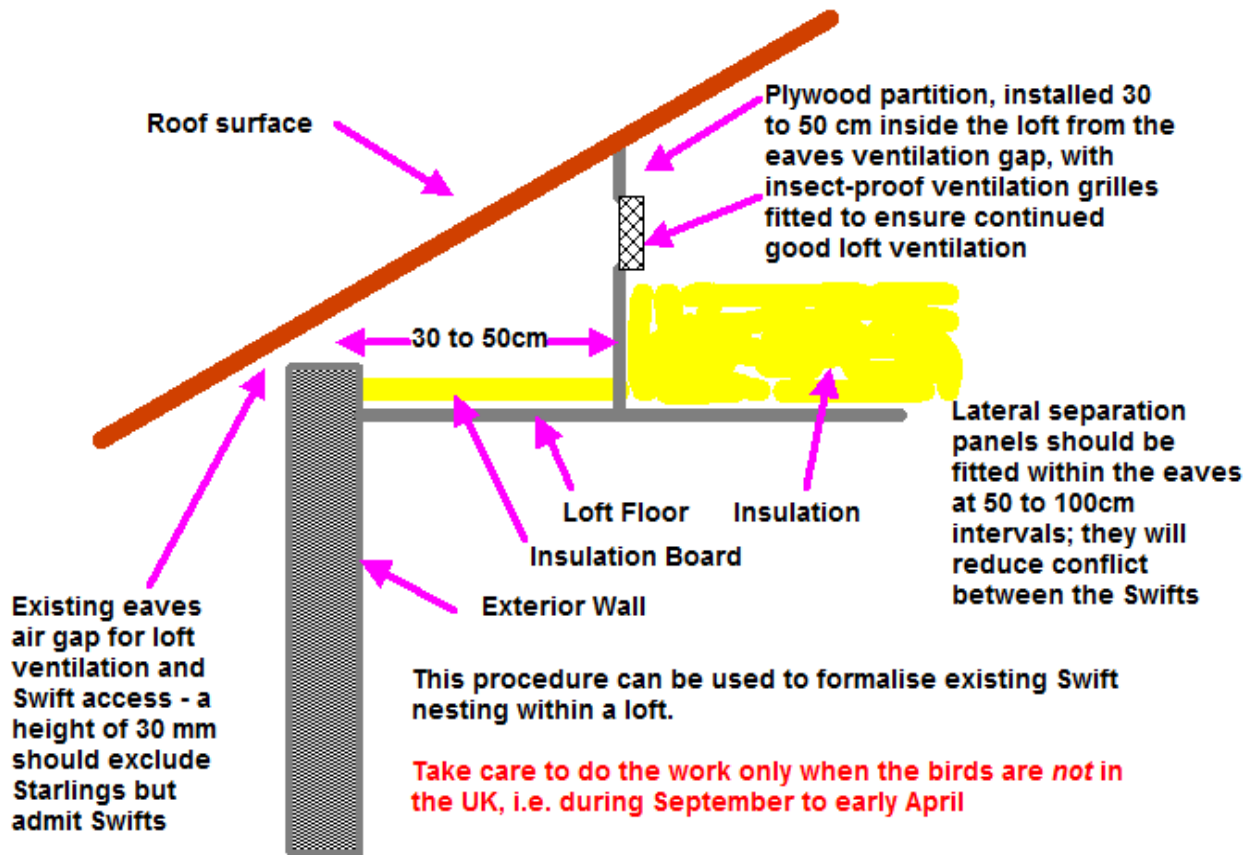
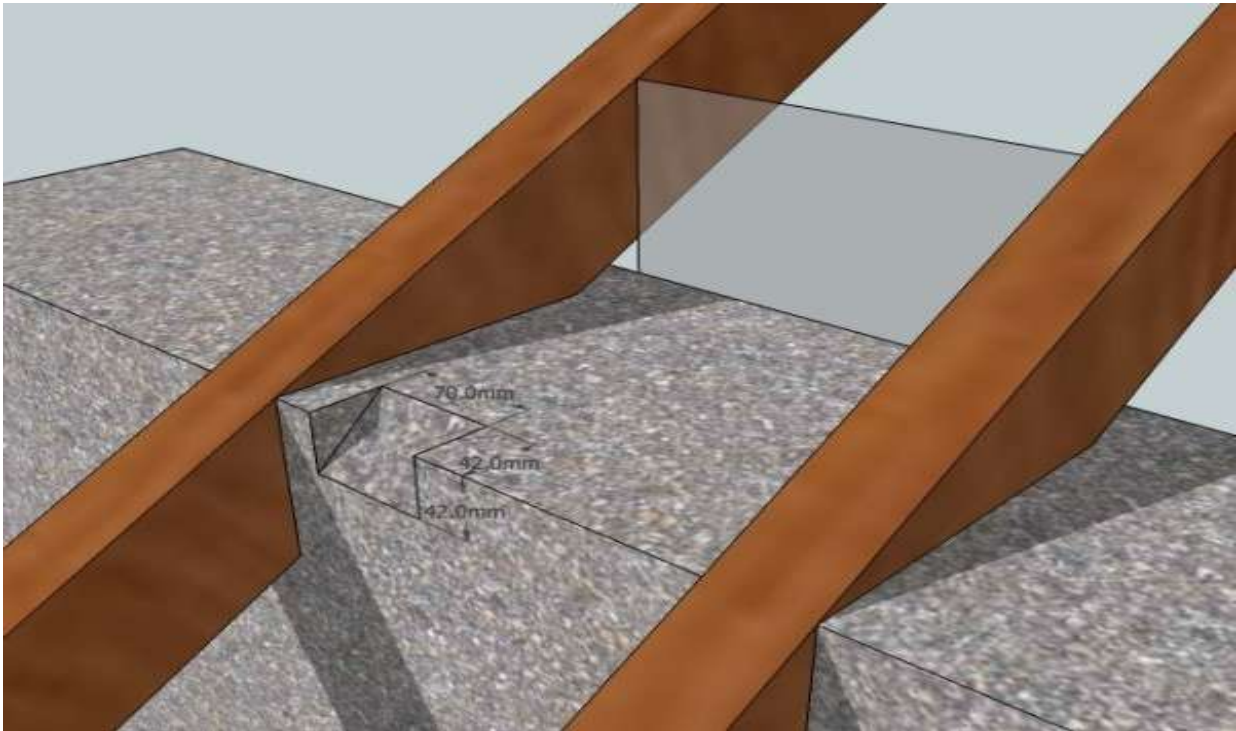
Above: examples of how to maintain Swift nest places in “open” eaves when these have to be rebuilt or re-roofed. For more advice and help on this and other ways of helping Swifts survive please contact Swift Conservation
